Pilot Test to Capture Water from the Flue Gas of a Coal-Fired Power Station

Frank de Vos, Paul van Daele, Jeff Gabster, Danny Sherban, Rony Mehr, Dror Yitzhak, Ines Bettermann, Stefan Weuster, Wolfgang Ansorge, Herman Teunis, Zandrie Borneman, and Ludwin Daal

ABSTRACT

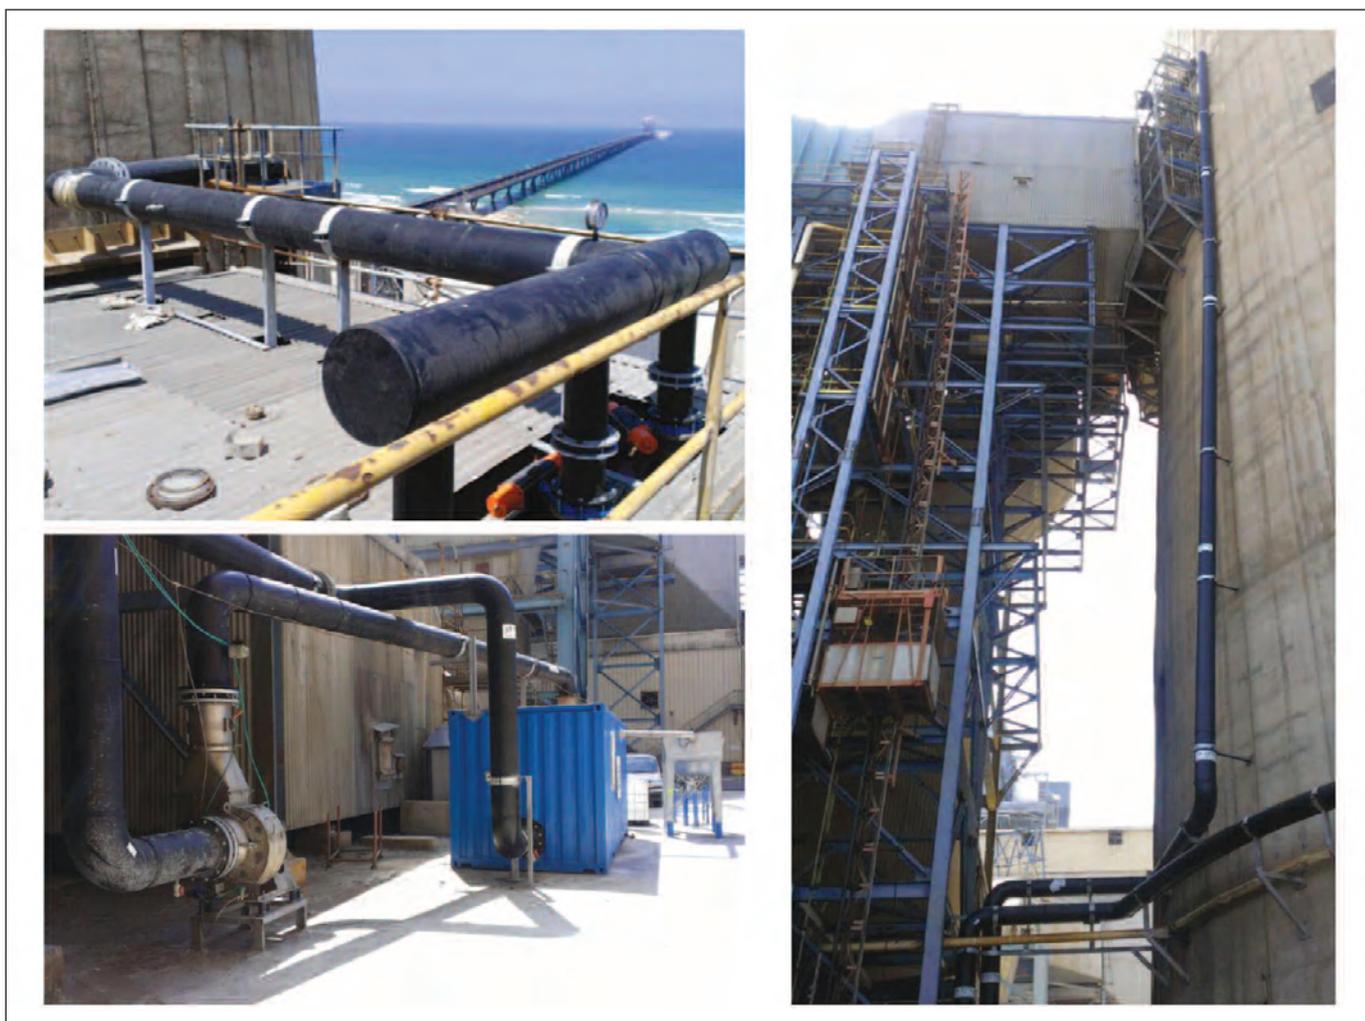
Figure 2:
Detail photos of extraction of flue gas from Unit 4 (top left), blower and test rig (bottom left), and pipework coming down from Unit 4 and part of return line back to Unit 3 (right).

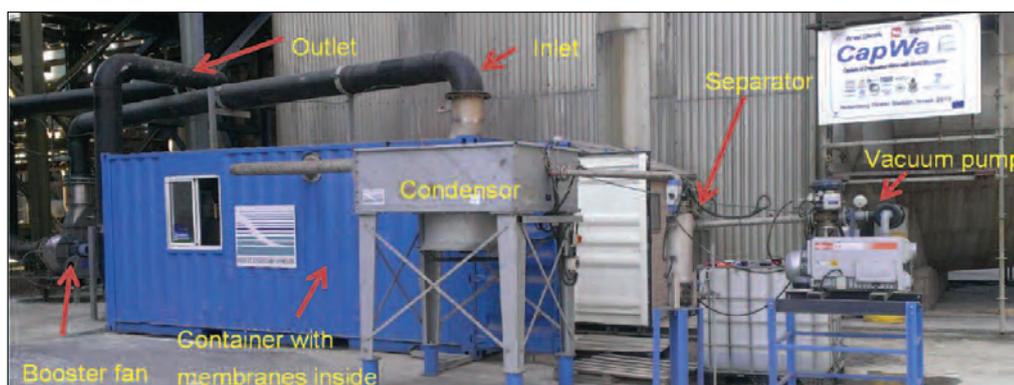
Figure 7:
Layout container.

In general the layout (Figure 7) of the pilot plant is comparable to that of the laboratory testing facility. The installation contains a feed side, a module holder with the membrane modules, a retentate pipe and a vacuum system. This vacuum system contains a cooler, a water collection unit and a vacuum pump. The main differences from the laboratory experiments are that the size is large, approximately 30 m^2 of membrane surface. Also it's the first time an air-cooled condenser is used instead of a water-cooled condenser. The unit houses 30 modules divided into 5 trains of 6 modules each Figure 8. All trains have two common headers, one for the feed flow and one for the retentate as depicted in Figure 9.

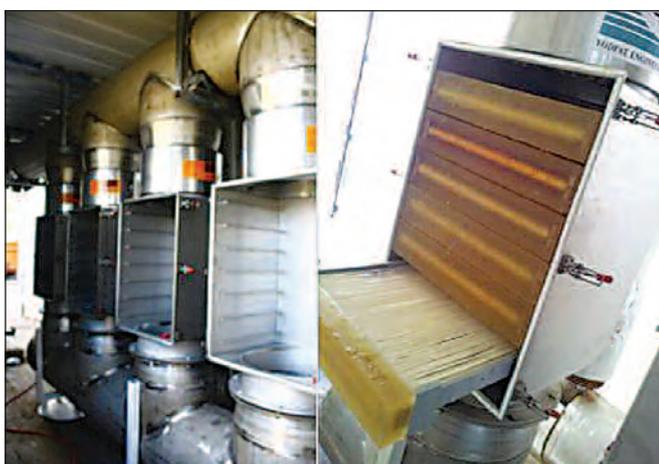
Figure 9:
Empty trains including headers and one train filled with six modules.

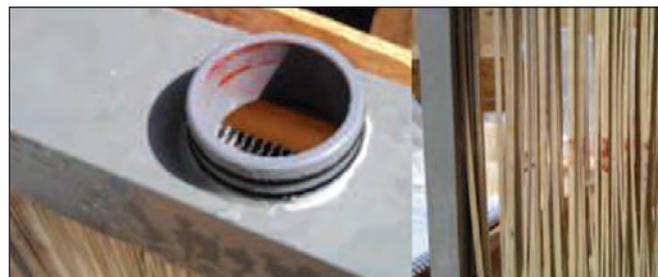
Figure 15:
Red stain, probably lead oxide, found on inside of permeate exit as well as on fibre.

In the SEM-EDS pictures it also seems that this material is penetrating through the membrane fibre. A picture of one of the outlets shows ([Figure 15](#)) that this material is found here. Another fouling compound found was primarily

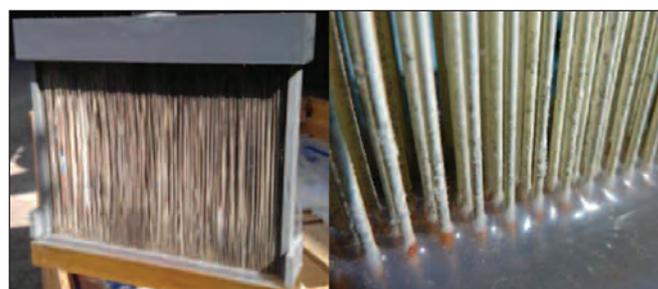
Figure 16:
Fouled membrane module after almost 3 months of exposure.

gypsum (Figure 16). It is known that fouling can cause a decrease in water flux performance as this material covers the surface. Luckily it also covers the end of the broken fibre and might act as a plug (see Figure 17). This can help reduce leakage.

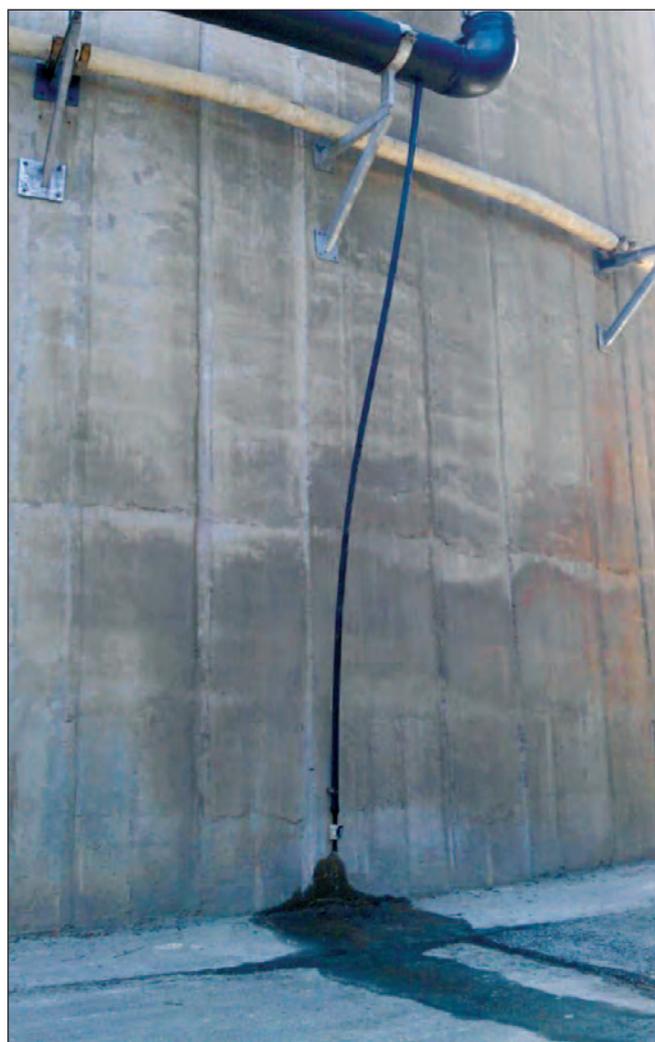
Figure 21:
Drain at return pipe.

In general it can be stated that the test was successful. The unit performed as expected based on laboratory tests and managed to run and remain running in harsh conditions. The test unit was user friendly with easy access to the membrane modules. Also broken fibres in a module could be easily identified and the module could be repaired. The likely cause of the broken fibres was turbulence of the flue gas flow in the last two trains. The turbulence could have caused the membranes to vibrate. While vibrating they broke. It is hence recommended to simulate the vibration behaviour and find out through CFD whether it is necessary to redesign the intake of the modules and how to do this. Another issue regarding plant layout was solved during the pilot test. During testing it was determined that water vapour in the returned flue gas (retentate side) condensed due to a temperature drop. This condensation was expected, only the construction was such that the water got trapped in the pipe work. An additional drain was installed to release the water, as shown in [Figure 21](#).
